The Cork Factory

masonry restoration • façade cleaning • pointing • historic restoration • terra cotta

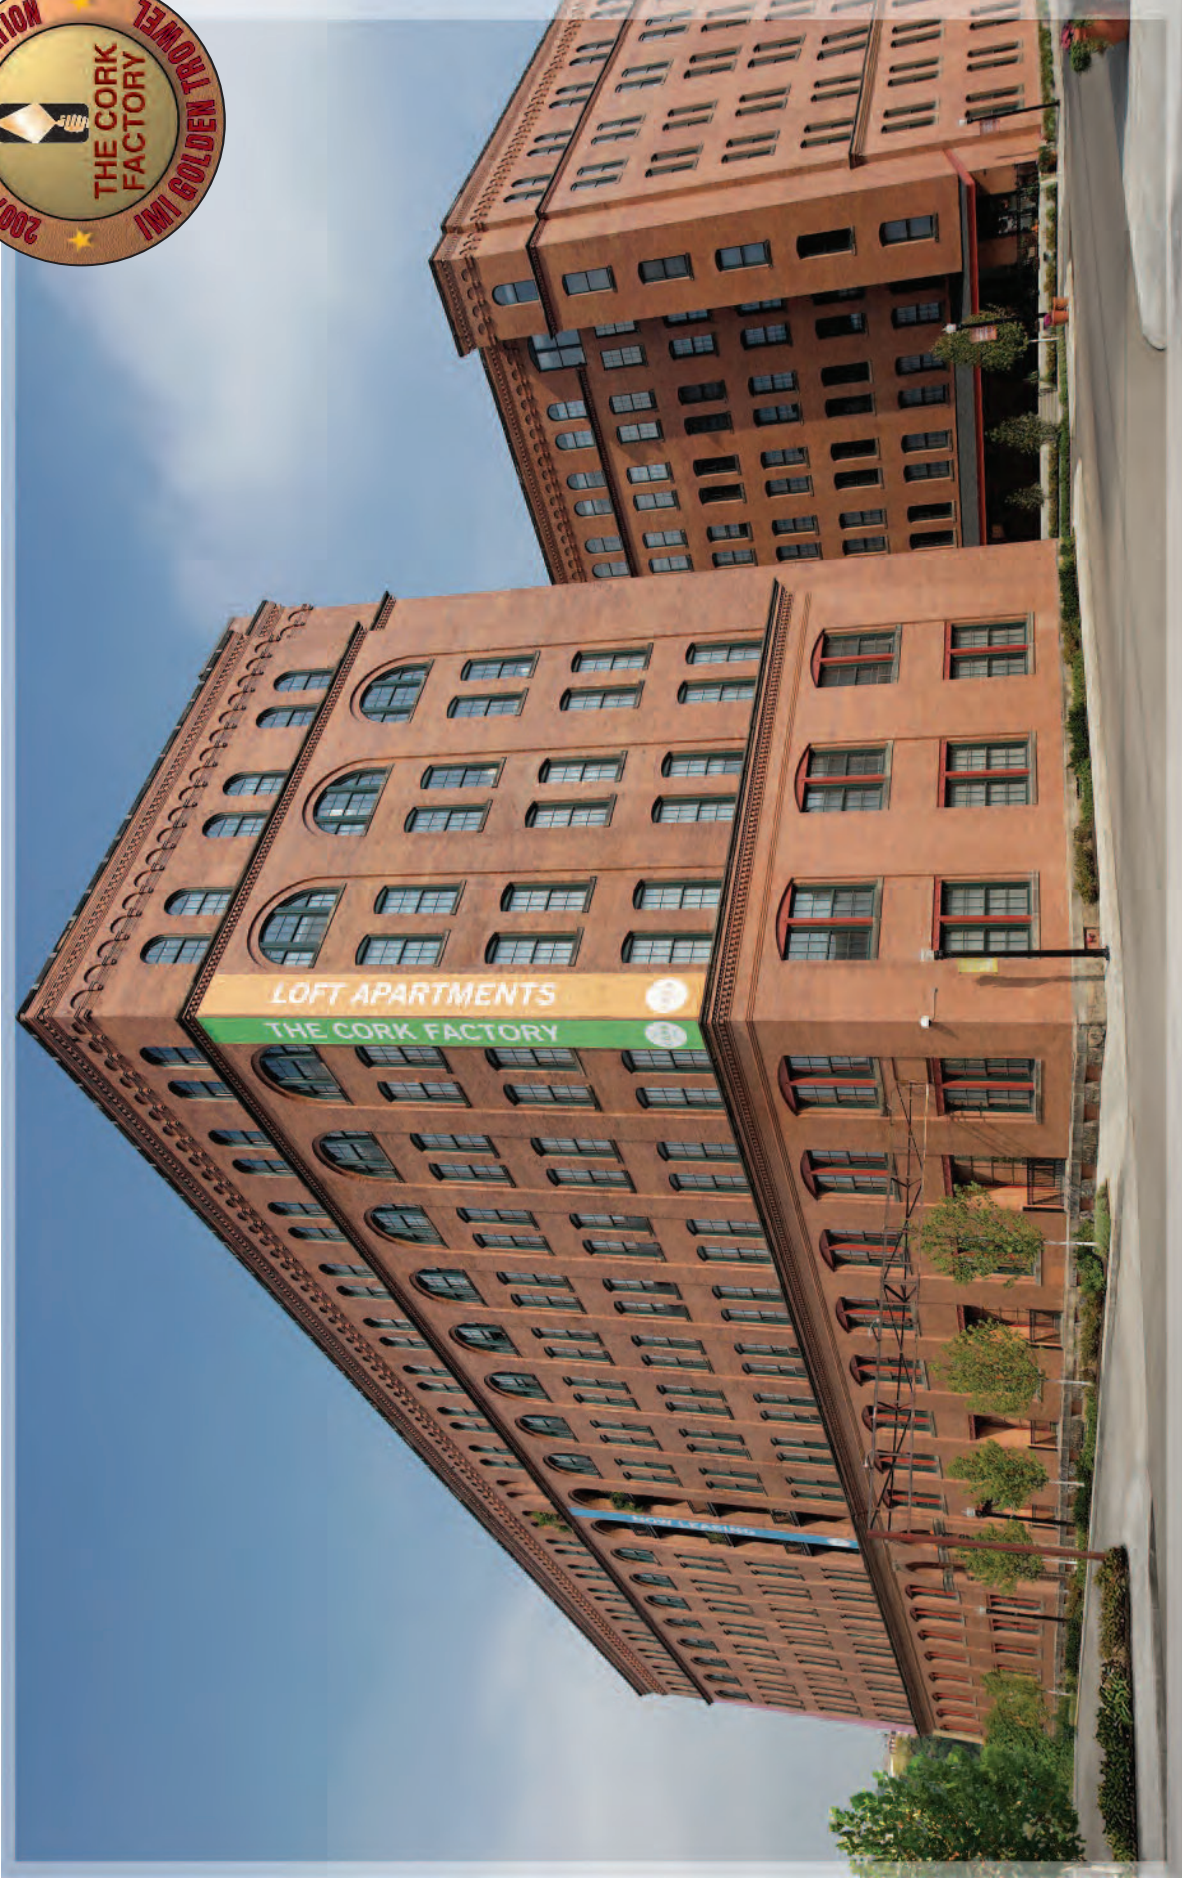
The Cork Factory is one of the most recognizable buildings in Pittsburgh, Pennsylvania's Strip District. Designed by the renowned Pittsburgh architect, Frederick Osterling, the imposing Richardson Romanesque-style structures comprise the 440,000-square-foot complex that was constructed in 1901 and expanded in 1913. Home of the Armstrong Cork Company until 1974, the buildings were abandoned for more than 30 years. In early 2005, McCaffrey Interests, a Chicago developer, partnered with the local owners of the buildings to develop 295 luxury apartments within the shell of the former industrial facility.

Graciano Corp. was assigned the task of cleaning all of the two-building facility's exterior brick masonry, stone and terra cotta surfaces. The company was also responsible for removing extensive accumulations of graffiti, as well as spot-pointing masonry joints, removing and replacing damaged brick, patching or replacing stone architectural features, and repairing damaged terra cotta trim on cornices, belt courses and window sills. Graciano encountered exceptionally heavy accumulations of dirt on the façade surfaces, and found it necessary to treat and clean exterior building surfaces two or three times to remove all foreign materials.

Graciano was subsequently asked to work on the complex's towering stack. The company encapsulated the brick structure in scaffolding, reconstructed the top three feet of brickwork, replaced metal stabilizer rings, cleaned and repointed the masonry surfaces, and installed a stainless steel cap on the stack to prevent water infiltration.

When the stack work was complete, the company was then invited to work on the reception building. Two of the building's three exterior brick walls were completely rebuilt to match the historic fabric of the surrounding structures. The third wall was refurbished with cleaning and pointing. Within the reception building, interior brick walls were constructed to define spaces. As a final assignment, the general contractor asked Graciano to install precast coping around the facility's new in-ground pool and adjoining Jacuzzi.
